ABSTRACT

This document describes the known exceptions to the functional specifications (advisories).

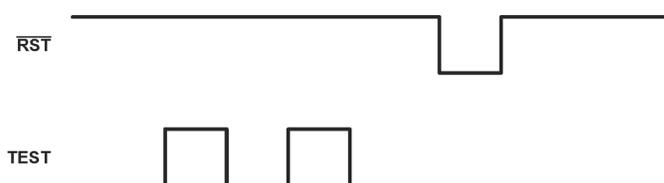
or

- Toggle the TEST pin twice when nRST is high and after 50us pull nRST low.

Note: This toggling of TEST pins is not subject to timing constraints. The appropriate level transitions on TEST pin, followed by a RST pulse after 50us, are sufficient to trigger an exit from BSL mode.
