Errata
MSP430G2303 Microcontroller

ABSTRACT

This document describes the known exceptions to the functional specifications (advisories).

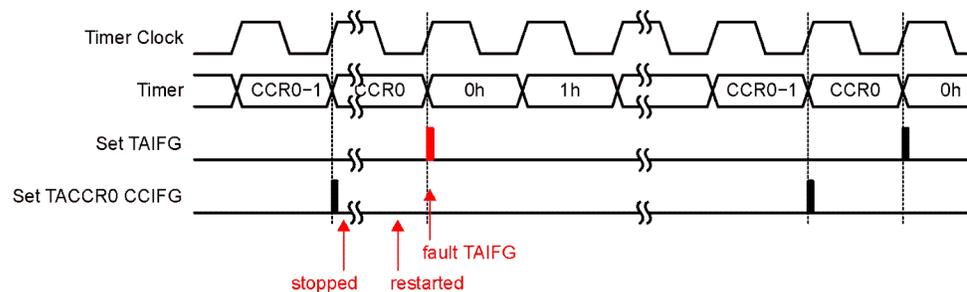
TA21 *TA Module*

Function TAIFG Flag is erroneously set after Timer A restarts in Up Mode

Description In Up Mode, the TAIFG flag should only be set when the timer counts from TACCR0 to zero. However, if the Timer A is stopped at $TAR = TACCR0$, then cleared ($TAR=0$) by setting the TACLr bit, and finally restarted in Up Mode, the next rising edge of the TACLK will erroneously set the TAIFG flag.

Workaround None.
