# USBXpress™ Family

## CP2102N Errata

This document contains information on the CP2102N errata. The latest available revision of this device is revision A02.

Errata effective date: March, 2019.

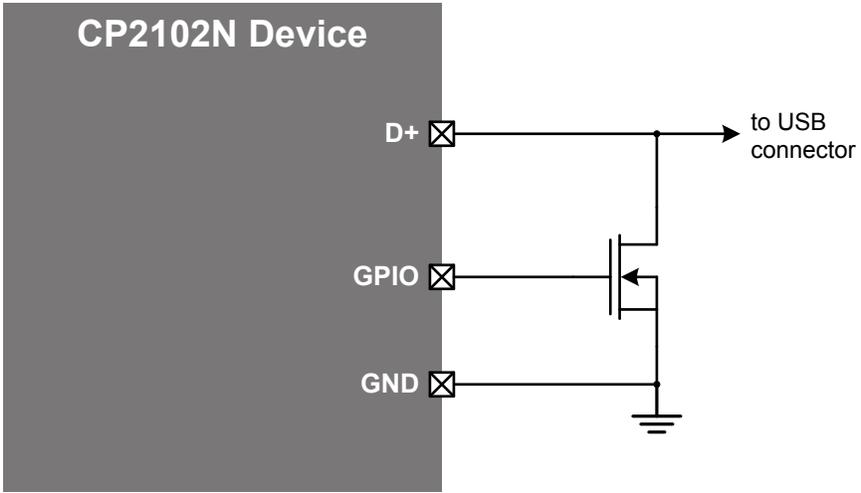
<b>Description of Errata</b>
During and immediately following power-on reset, the USB D+ and D- pins are undefined. These pins can be logic high, logic low, or mid-supply. This behavior typically lasts for ~15 ms, at which point the D+ and D- pins operate normally. The USB specification provides a 100 ms settling/debounce period after power-on.
<b>Affected Conditions / Impacts</b>
Some USB host devices may require the USB D+ and D- pins be in a known state during or immediately following power-on reset to start properly.
<b>Workaround</b>
<p>Adding an external circuit to the USB D+ and D- pins can force the desired state on these pins during and immediately following power-on reset. The rising edge of RSTb signals the end of power-on reset.</p> <p>An example circuit is shown below:</p> <div style="text-align: center;">

<p>The diagram shows a grey rectangular block labeled 'CP2102N Device' on the left. Three pins are indicated: 'D+', 'GPIO', and 'GND'. The 'D+' pin is connected to a horizontal line that leads to an arrow pointing right, labeled 'to USB connector'. The 'GPIO' pin is connected to the gate of an NMOS transistor. The 'GND' pin is connected to the source of the NMOS transistor. The drain of the NMOS transistor is connected to the line between the 'D+' pin and the 'to USB connector' arrow. The gate of the transistor is also connected to a vertical line that goes up to the 'D+' pin, forming a feedback loop that shorts D+ to ground when the transistor is turned on.</p> </div> <p>This circuit uses an NMOS transistor and a GPIO pin to short D+ to ground during power-on. The GPIO pin will be open drain and pulled high through a weak pull-up during reset. The GPIO should be configured so that the [Reset Latch] value is [Low], which turns off the transistor after reset and enables the device to enumerate normally. GPIO can be configured using Xpress Configurator in Simplicity Studio v4 (<a href="http://www.silabs.com/simplicity">www.silabs.com/simplicity</a>).</p>

<b>Resolution</b>
There is currently no resolution for this issue.
